Track Engineers Report Brookhouse 04/08/06

Rail defects

Malsby 6m01c to 7m0c

02 Aug 2006

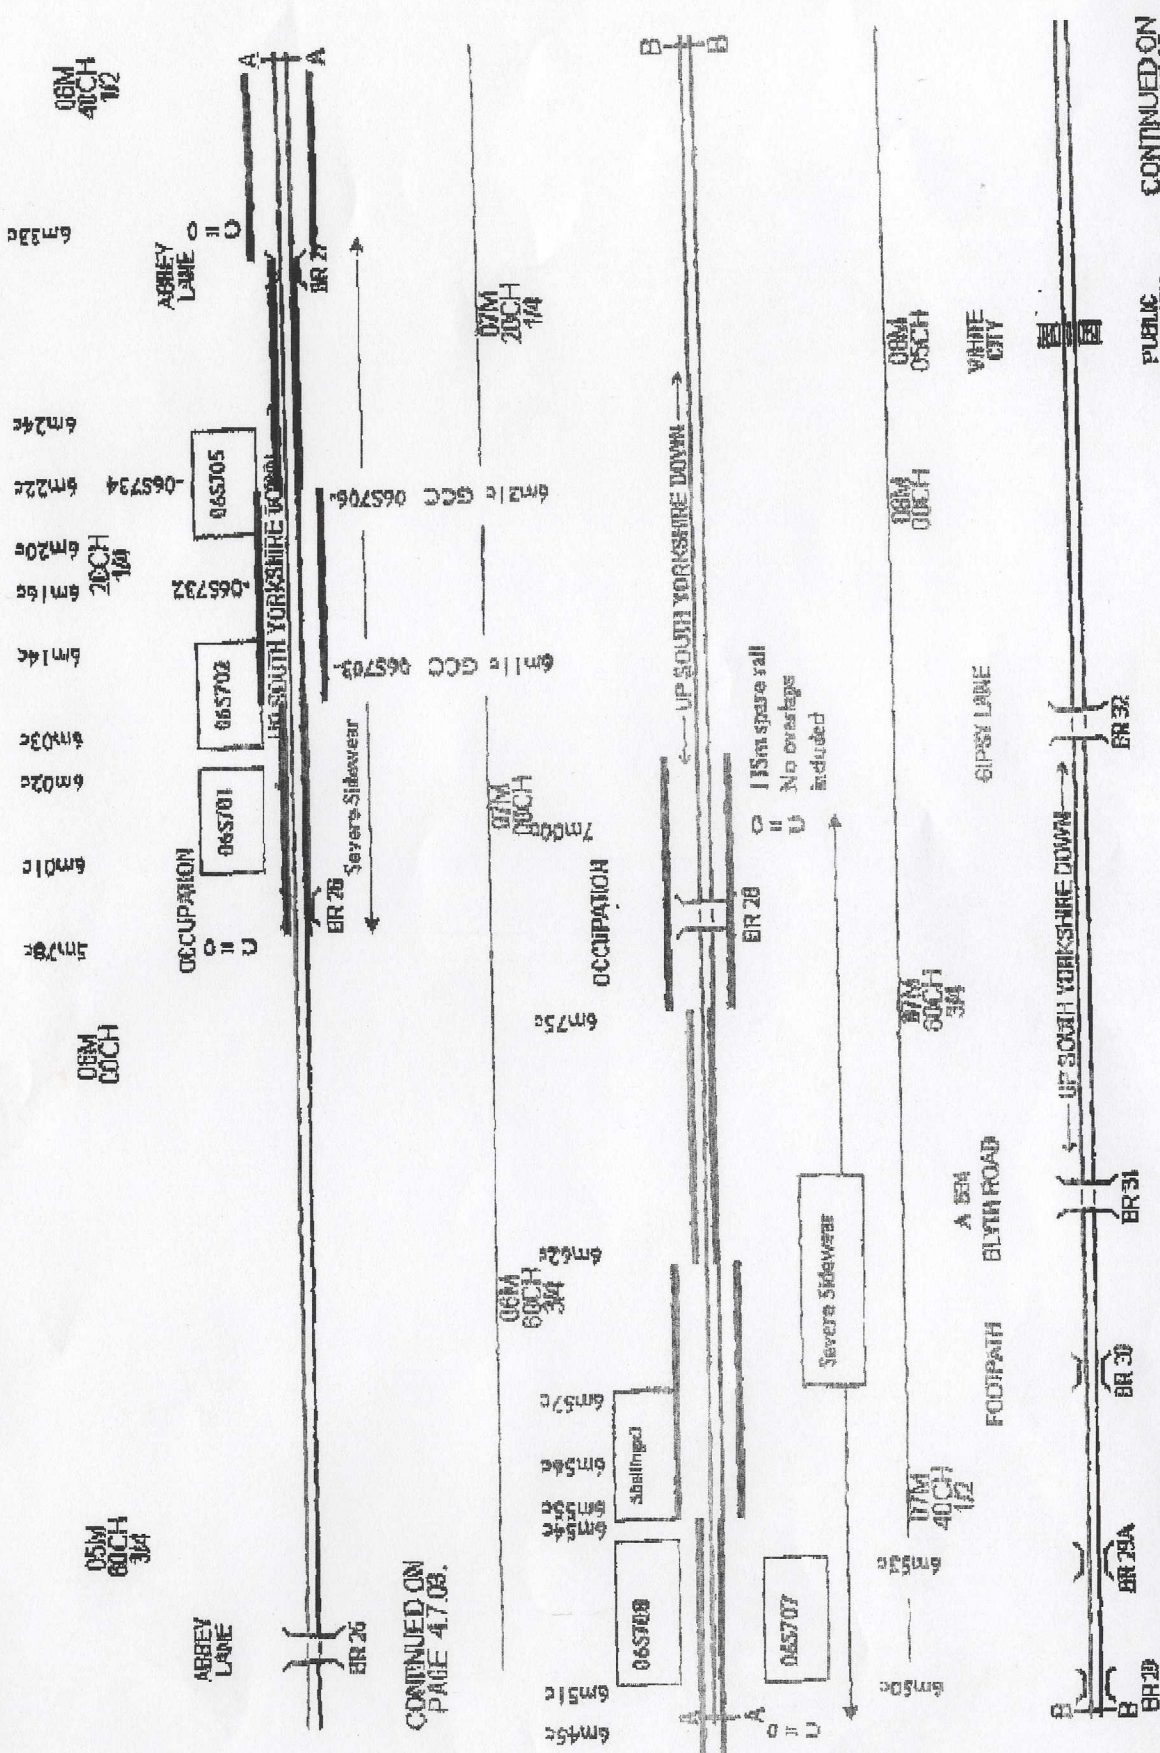
- 1.0 Description of Problem and solution (and an appendix a to be completed)
- 2.0 Line diagram of the defect rails and other defects and proposed CWR drop.

Due to the number and location in the rail of the defects it is not reasonable to remove the defects with closure rails. Therefore CWR is required to be dropped and installed, the earliest opportunity is midweek 23.
